Concrete NDT

City of Phoenix Uses GPR to Inspect Lined Sewer Pipes

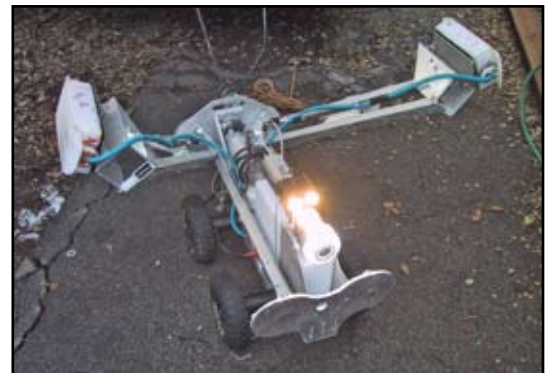
GPR positively identified deterioration in two of the pipe runs. There were three locations within the GPR file where the video-identified defects correlated exactly with locations on the GPR profile identified as deteriorated.

After the assessment, GEOVision recommended that the City of Phoenix take sample cores of the pipes to give a final confirmation of the deterioration. A limited number of defects were found in the pipes overall, so only periodic GPR inspection was recommended by GEOVision in order for the city to monitor possible larger issues that may arise in the future.
