GEOPHYSICAL INVESTIGATION MT. GENERAL FAULT, SAN BERNADINO COUNTY, CALIFORNIA

Project Description

A geophysical investigation was conducted to map the location of the Mt. General Fault near the Lenwood Hinkley Sanitary Landfill. The purpose of the investigation was to locate the fault so that groundwater monitoring wells could be appropriately placed. Several geophysical techniques were utilized to locate the fault including seismic refraction, electrical resistivity imaging and magnetics.

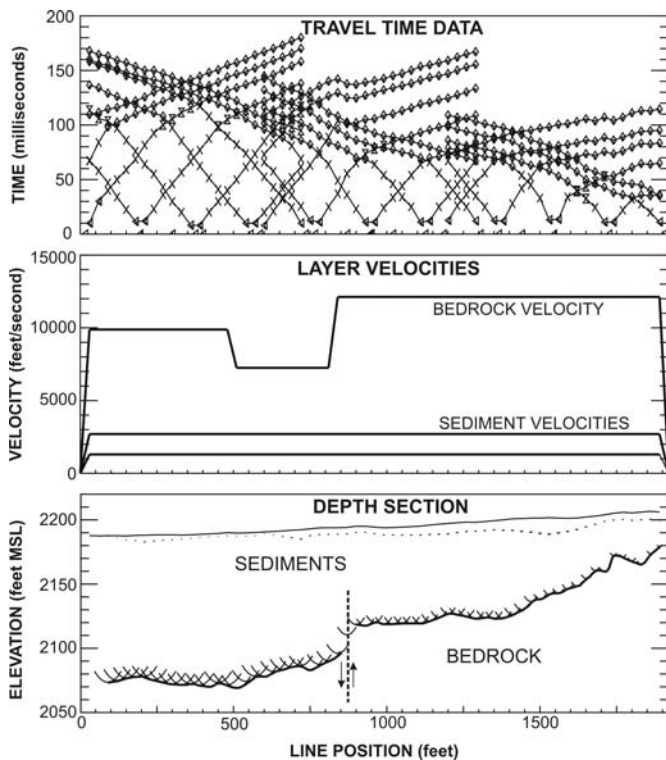
Figure 2
Seismic Refraction results

The seismic refraction method was able to map bedrock topography in the vicinity of the fault and revealed that bedrock was abruptly downthrown on the southwest side of the fault (Figure 2). There were also significant contrasts in bedrock velocity on both sides of the fault. Bedrock depths are underestimated on the southwest side of the fault as the water table was found sitting immediately above the bedrock surface on the upthrown block and was a hidden layer on the downthrown site of the fault.

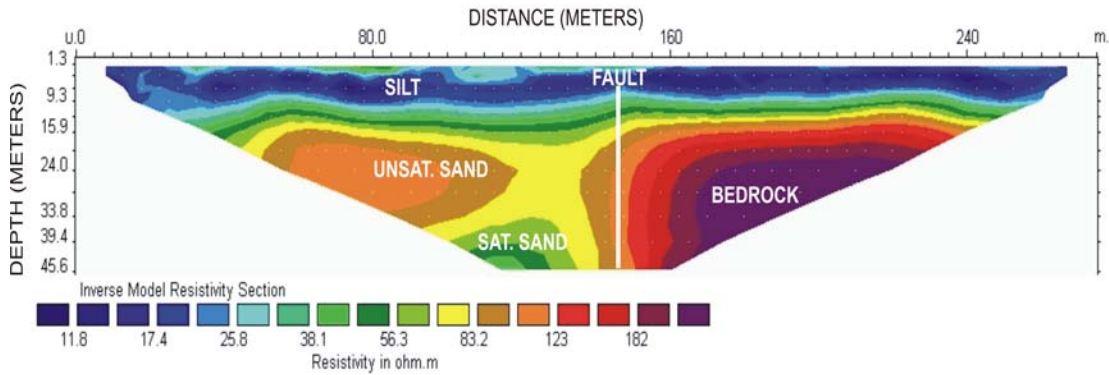
Figure 3 Resistivity Survey results

The resistivity survey (Figure 3) also revealed the location of the fault but the profile was not long enough to image the bedrock surface on the downthrown side of the fault. Although the resistivity survey was unable to image the contact between coarse-grained sediments and bedrock on the upthrown side of the fault it did provide some evidence of saturated sediments on the downthrown side of the fault.

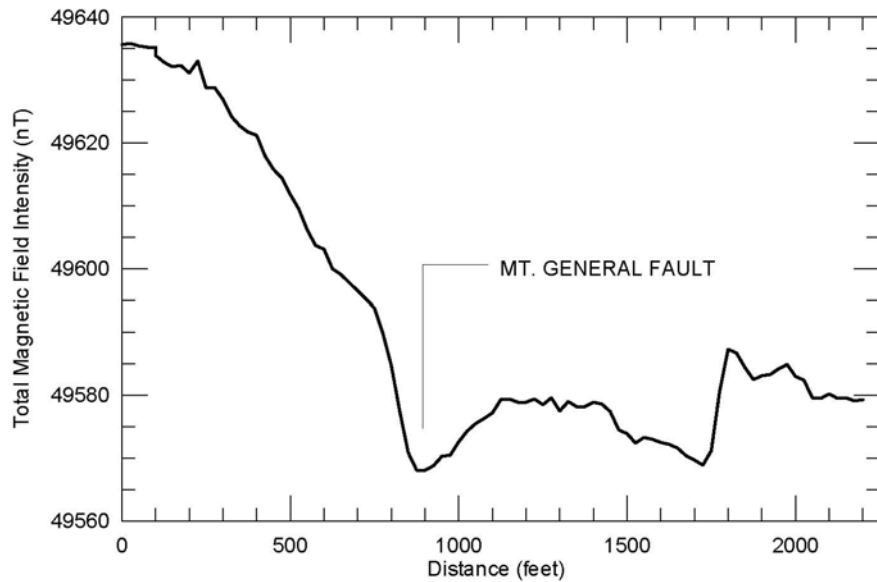
Figure 4
Magnetic Survey results

A magnetic survey (Figure 4) also located the fault with a magnetic high on the downthrown side of the fault indicating different bedrock types on each side of the fault with the bedrock on the downthrown side of the fault having a higher magnetic susceptibility than that on the upthrown side. This contrast in magnetic properties of bedrock on both sides of the fault continued about 2 miles to the northwest, at which point the magnetic method was unable to map the fault indicating that similar bedrock types were located on both sides of the fault to the northwest.
